# Process Compensated Resonance Testing CF6-80A 1<sup>st</sup> Stage HPT Blade

September 24, 2008

**Vibrant**

**DELTA**

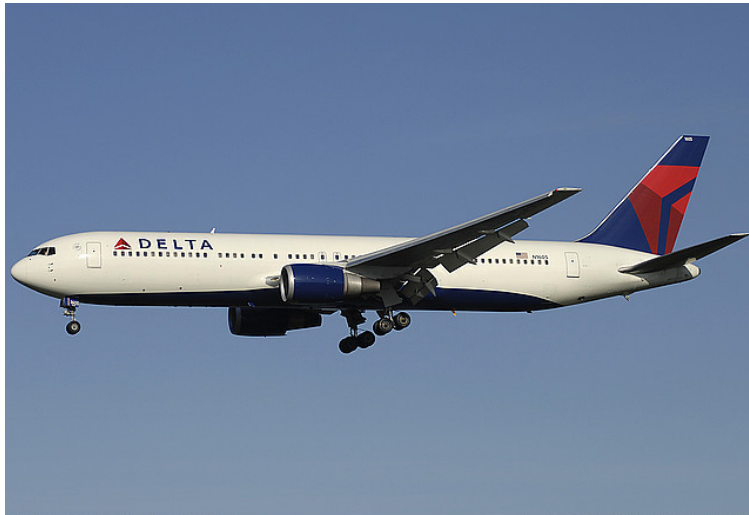
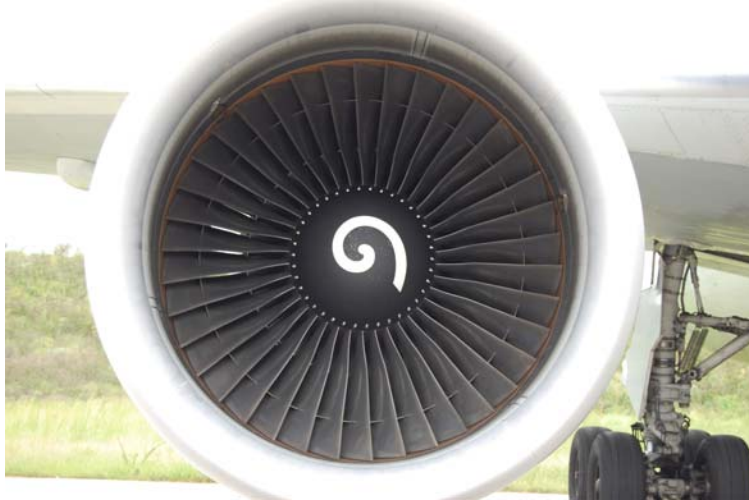
- Brazed end-caps
- No Standard NDT method inspection available
  - Repair and Overhaul X-ray and FPI methods prove to be inconclusive in detecting braze interface cracking.
  - Blades returned as serviceable are still considered suspect.
- New part number replaces brazed tip cap blades with cast blade (including cap)
- Failure results in loss of HPT blades and damage to downstream components

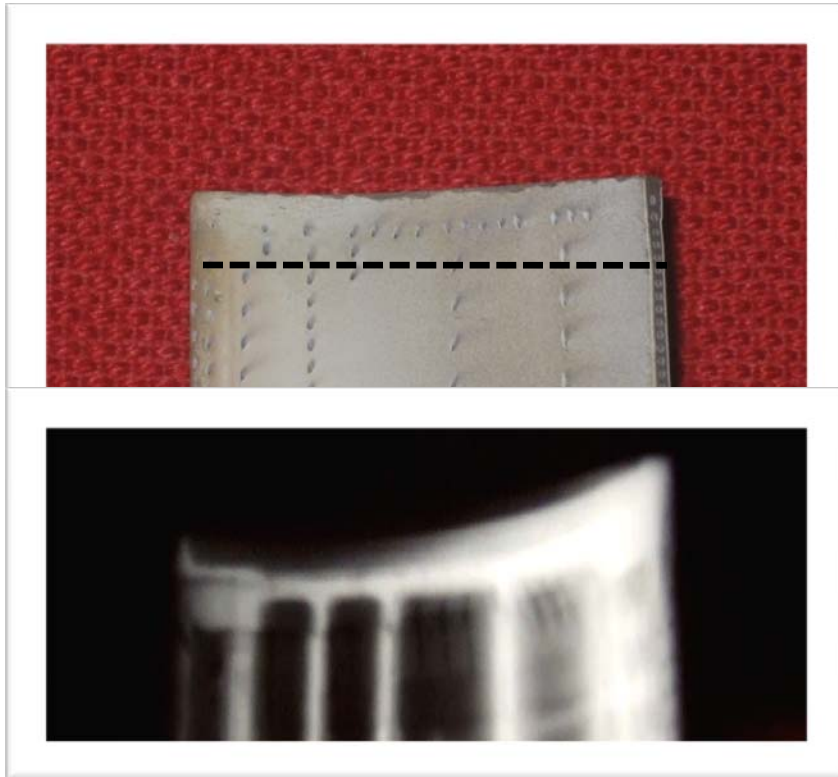
## CF6-80A 1<sup>st</sup> Stage HPT Blade

- 5 Failures attributed to brazed tip cap liberation – EXPENSIVE!
- 20+ unscheduled engine removals – EXPENSIVE!
- Delta reliability initiative = pull all blades with > 10,000 hrs and scrap/quarantine
- Estimate premature removal of 1500 blades with an average of 50% of life still remaining – EXPENSIVE!
- Blade potentially reclaimed if inspection technique examines braze integrity
  - Blades which fail inspection could be repaired

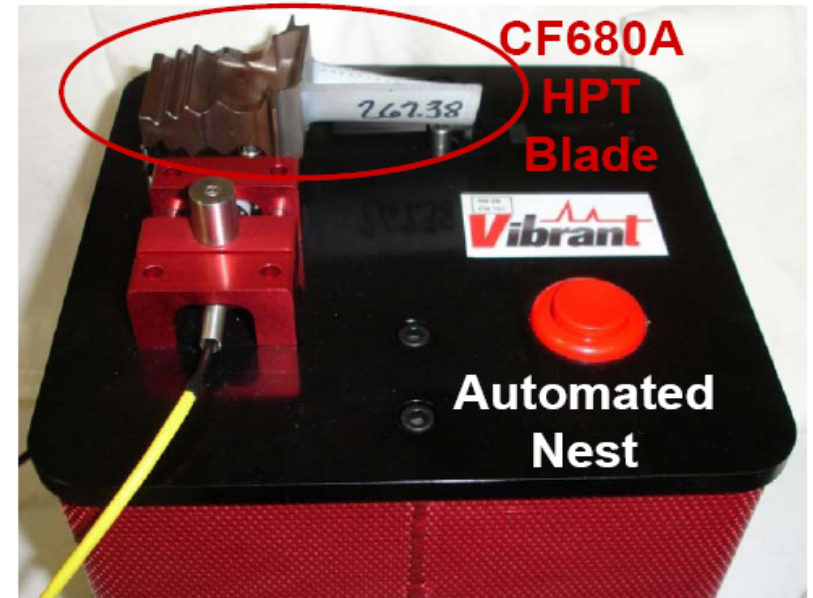
## Process Compensated Resonance Testing with Vibrant Corporation fixed nest

- No requirement to coating strip or surface prep
- Eliminates structural integrity suspicions
- Eliminates acceptance of hidden structural defects
- Eliminates corrosion concern in Engineering
- Improves inspection methodology and reliability

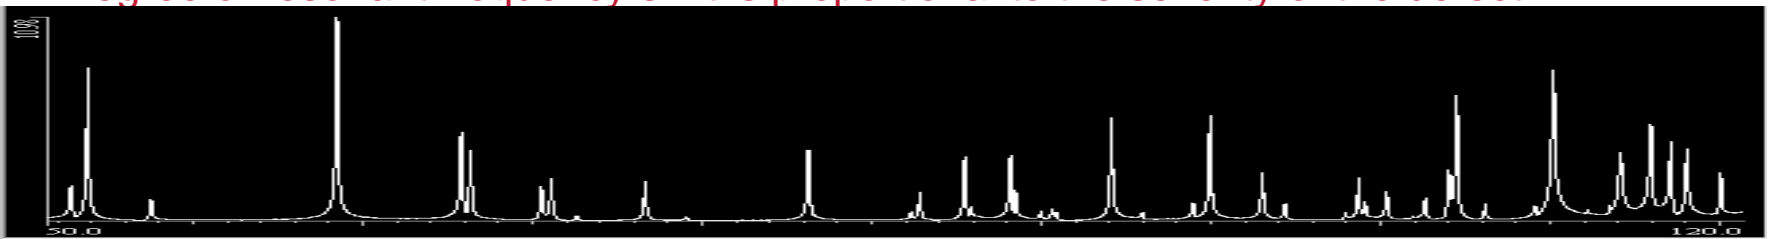
**Resonance Spectra**

**Structural Defect** = Strength reduction caused by degraded material properties or dimensional variation

e.g., a crack reduces stiffness and lowers the resonant frequency

Degree of resonant frequency shift is proportional to the severity of the defect

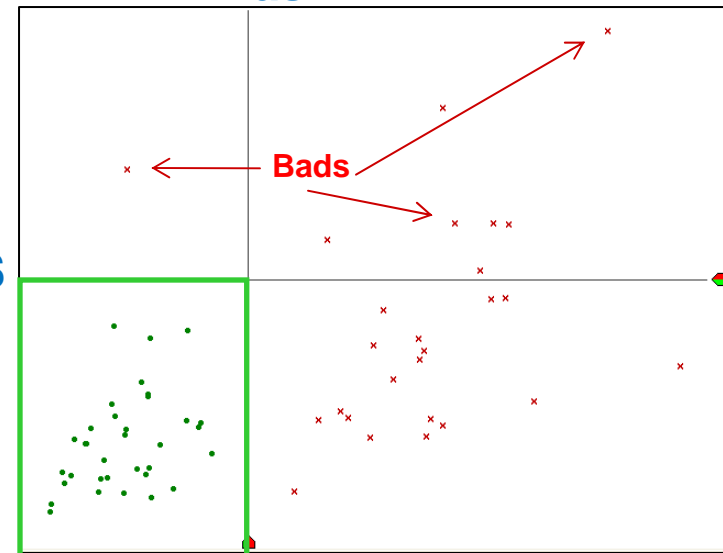
**PCRT calculations** MTS (Mahalanobis-Taguchi System) characterizes acceptable parts & variation and a Bias score characterizes unacceptable parts

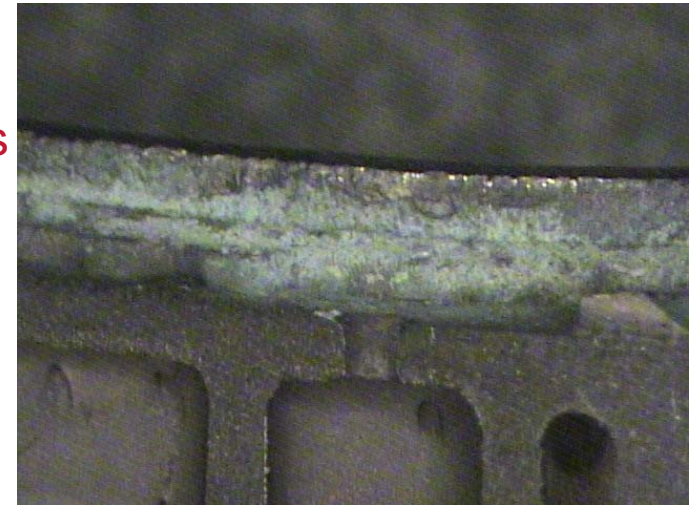
- 325 blades scanned with PCRT
  - Sort developed based on braze quality
- Typical Failure details:
  - Braze interface under the cap breaks down from fatigue or inadequate diffusion
  - Because the cap contact is limited to the leading edge, cavity one, and the internal partitions, the cracking almost always propagates toward the leading edge
- Blades identified with PCRT as suspect
- 30 blades sent to Sandia National Labs for CT scans
- X-ray performed at Chromalloy
  - Level III examined, compared to PCRT results
- Visual for LE cracking performed by two Level IIIs
- 10 blades exhibit cracking from CT scans

**PCRT results correlate well with other techniques**

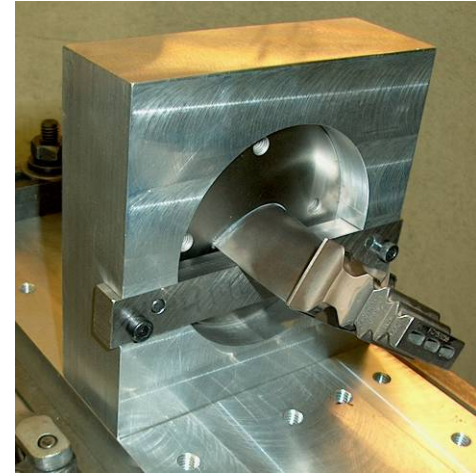
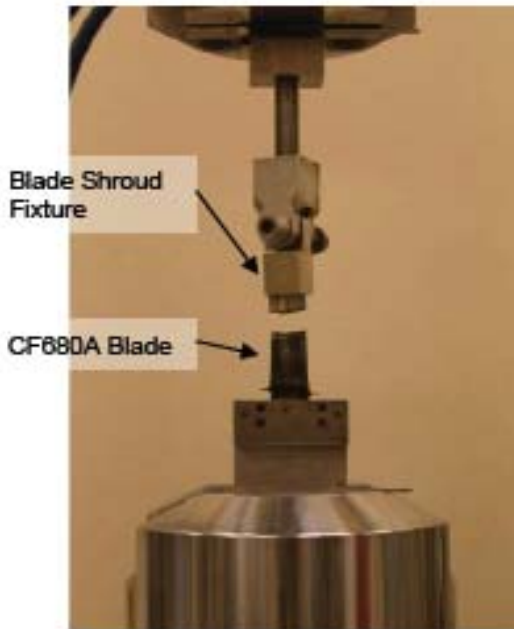
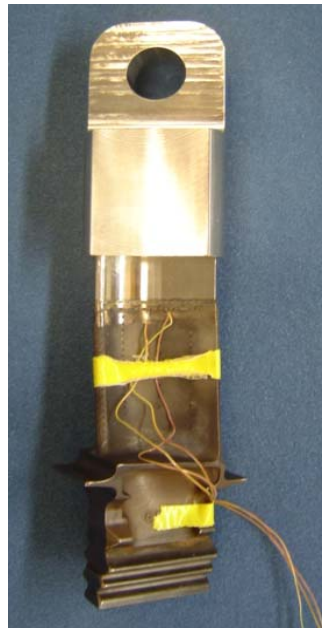
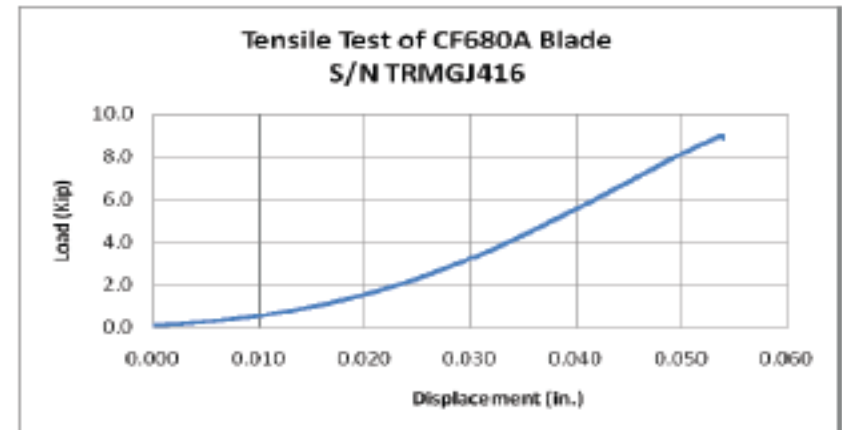
- DESTRUCTIVE TESTING AT FAA-AANC
  - Torsional test
    - Twist, fail at highest stress point
  - Tensile test
    - Laser welded fixture to cap

**PCRT results correlate well with destructive testing**

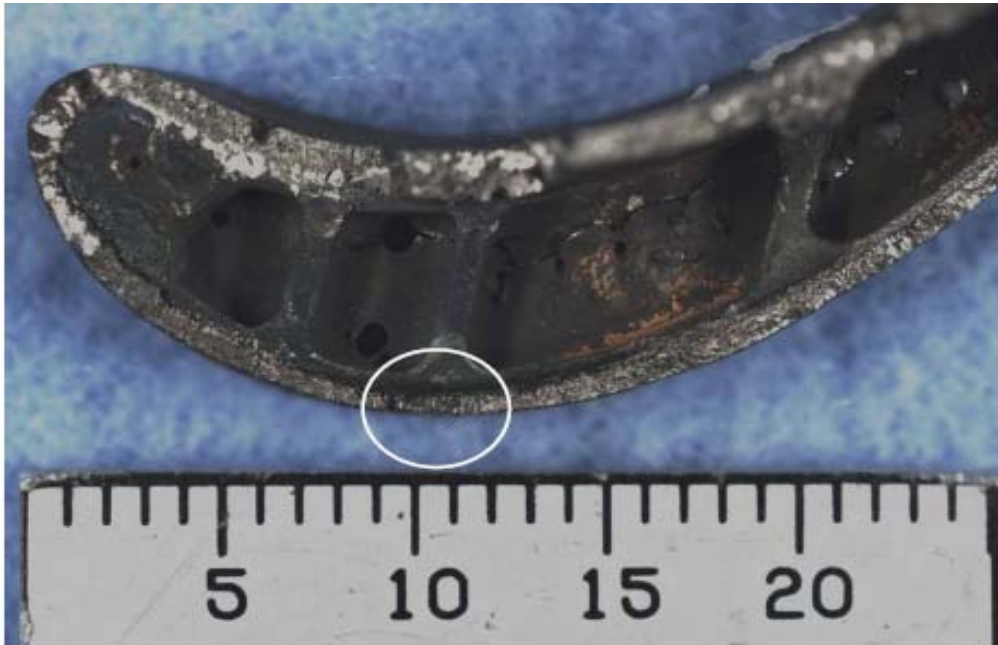
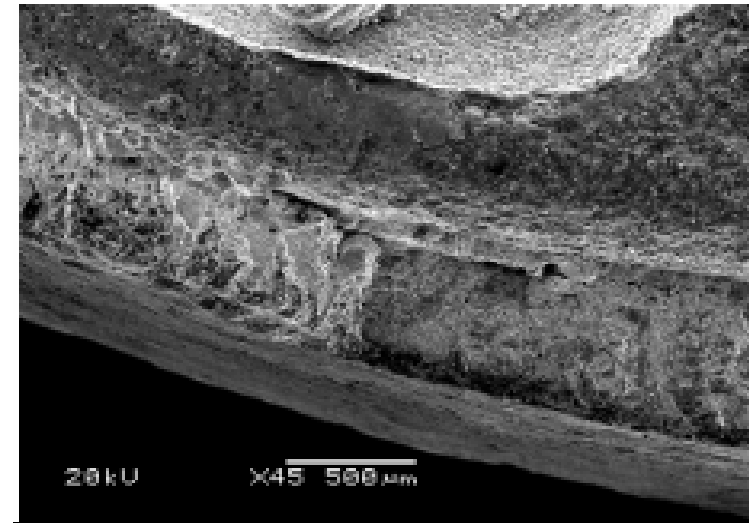
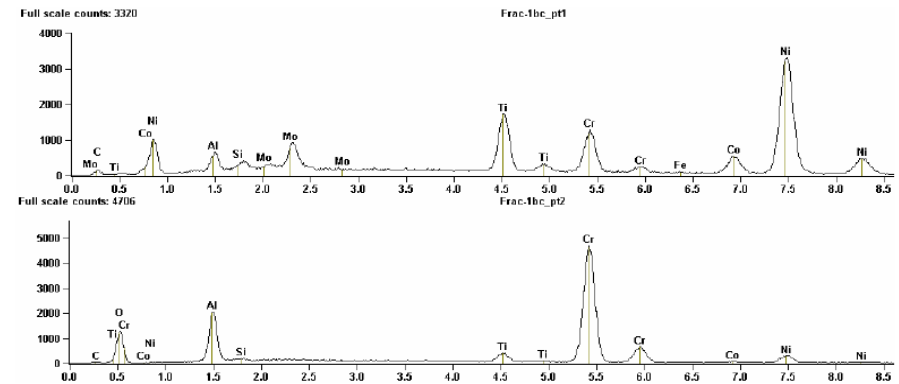
- Fractography at Sandia National Labs
  - SEM confirms braze defect
  - Elemental compositions via Energy Dispersive Spectroscopy (EDS)

**PCRT results correlate well with fractography**

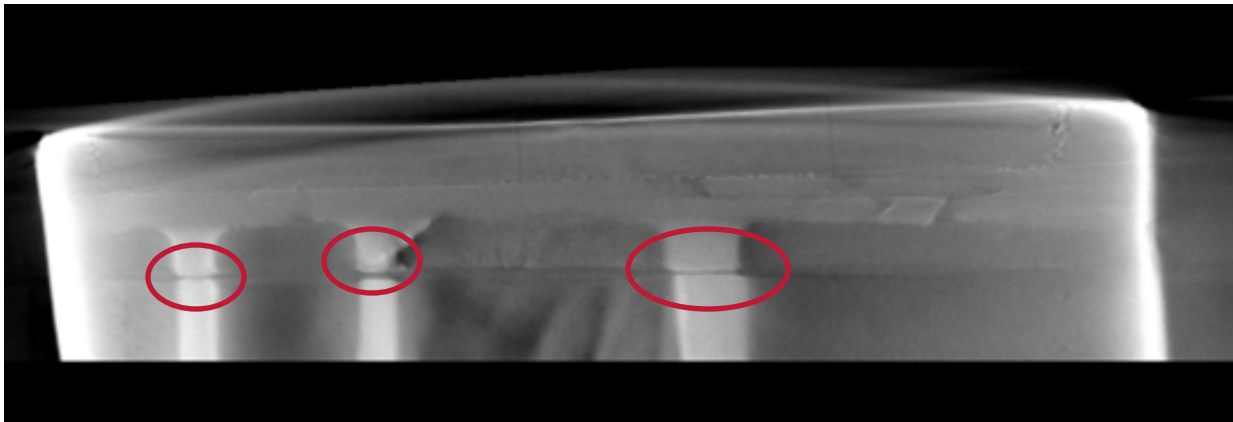
- CT scans at FAA-AANC
- X-ray at Chromalloy
  - Reject criteria for a brazed tip cap gap is as follows:
    - (a) A gap of .005 inch is permitted between the tip cap and blade ribs 3, 5, & 7. A gap of .010 inch is permitted between the tip cap and rib 1 of the blade.
    - (b) Braze alloy must not flow into cavities beyond .100 inch from the bottom of the tip cap. Braze is not permitted around the trailing edge pin fins which are more than .050 inch from the bottom of the tip cap

Unacceptable

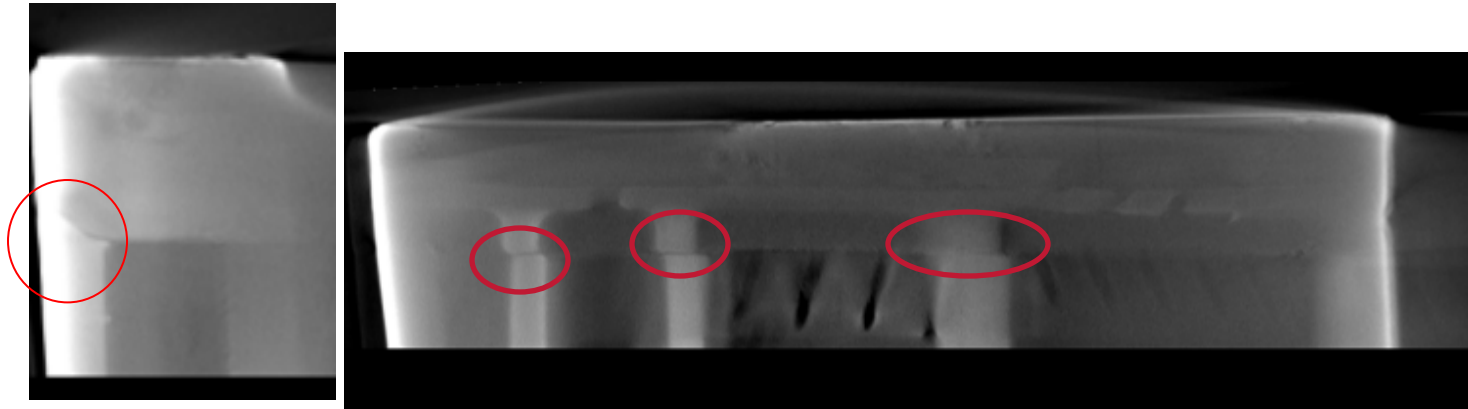
Unacceptable – crack at LE, 0.005” gap mid-web

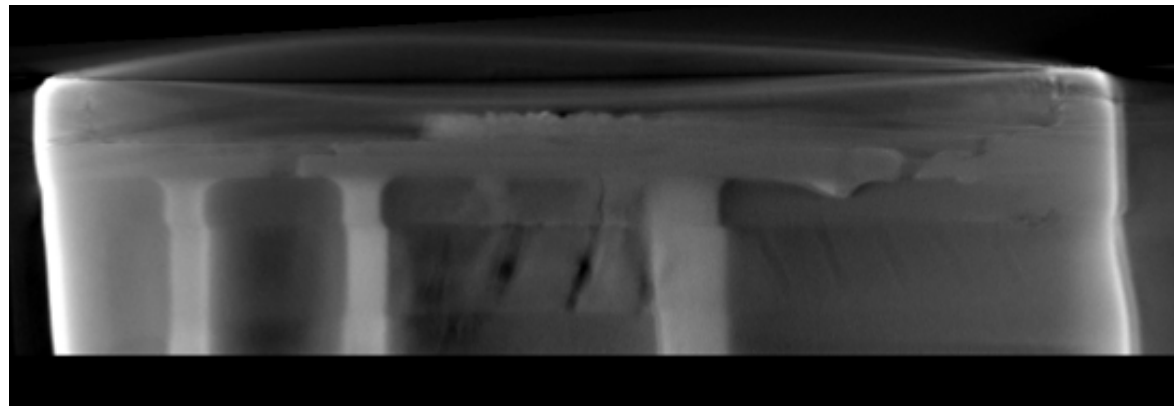
Acceptable – no indication of gap
